NASA/TM-2009-215955

# Experimental Behavior of Fatigued Single Stiffener PRSEUS Specimens

*Dawn C. Jegley  
Langley Research Center, Hampton, Virginia*

December 2009

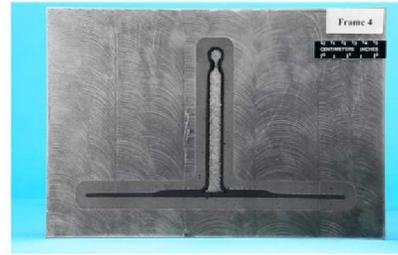
d) Frame specimen F4

Prior to delivery to NASA the OML of specimen F4 was damaged during the machining process. A photograph of this damage is shown in figure 7. The dent is approximately circular with a 1-inch diameter and the maximum depth is approximately 0.1 inches. No damage at this location is visible on the stiffened or Inner Mold Line (IML) side of the specimen.

Results for gages away from the pre-test damage site in specimen F4 and the equivalent location on specimen F3 are shown in figure 20a while gages near the pretest damage site in specimen F4 and the comparable locations in specimen F3 are shown in figure 20b. These results indicate that the damage has little impact on strains for loads less than 41,000 lb, which is the maximum load the specimens were subjected to during the fatigue cycling. However for loading greater than this level, the damage had significant influence on strain behavior in the region of damage, causing loss of load-carrying ability at the damaged skin at a load of approximately 50,000 lb rather than the 83,000 lb found in the undamaged specimen.

In frame specimen F3 the peak axial strains in the OML are located near the specimen corner. In frame specimen F4 peaks in axial strain also occur at the damage site. Since the VIC system only monitors the OML, initiation of failure on the IML could not be captured in this manner.
